- Reply: 1. a) Acute STEMI
 2. a) inferior; b) lateral; c) posterior; d) RV
 3. e) Proximal RCA

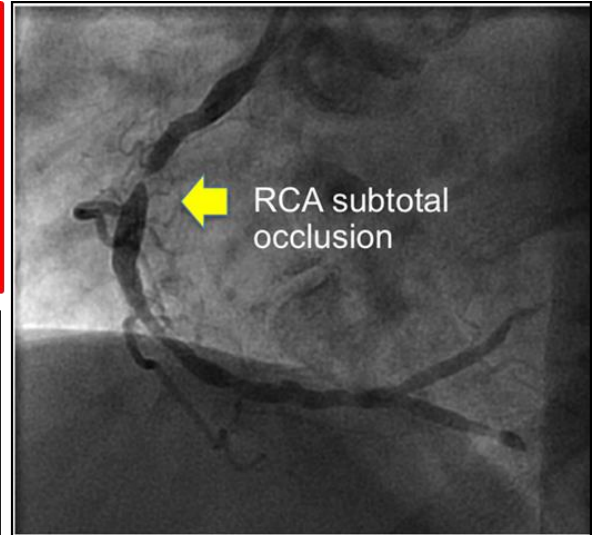
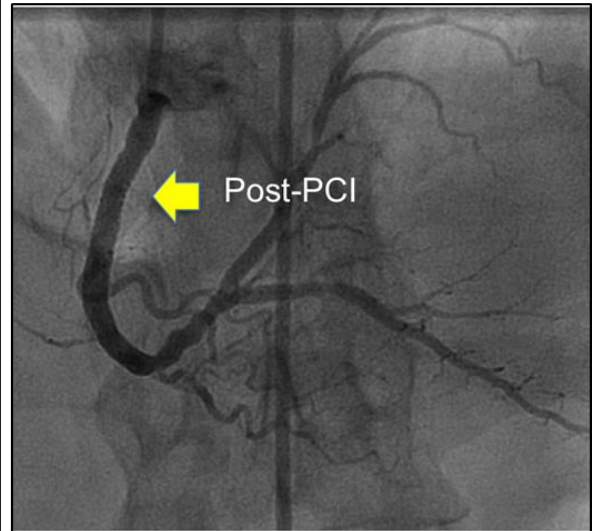
V4R

Right sided leads placed using leads V4, V5 and V6 on the right precordial region, should help assess if there is RV injury, as seen with proximal RCA occlusion (prior to RV branches). In such case V4R, should have STE > 0.5mm.

Proximal occlusion of right coronary artery

STE > 0.5 mm
 And a positive T wave

Distal occlusion of right coronary artery

No ST-segment elevation and a positive T wave

Occlusion of circumflex coronary artery

ST-segment depression of 21 mm and a negative T wave
